Property Survey Notes on the Legionella Risk Assessment of:

Name: Tarporley Community Centre

**Address: High Street
Tarporley
CW6 0AY**

Report Date: 08/08/18

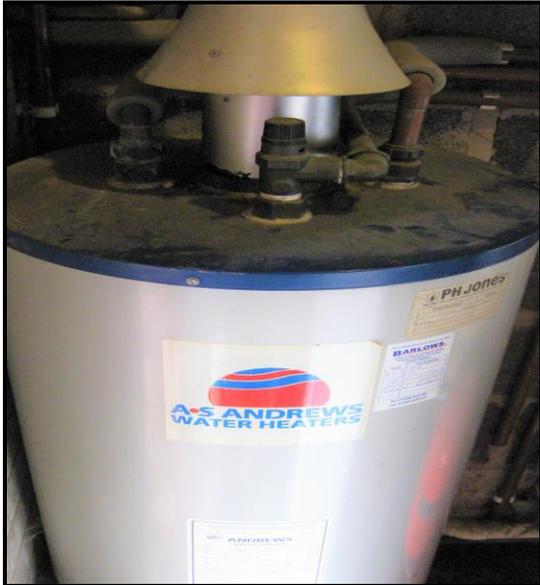
| RAR / Survey Results Reference | Comments and Action Required |
|---|--|
| <p>Low</p> | <p>There are two water heaters located on site. WH 1 is located in the Lower Ground Floor Plant Room (see photo 1). WH 2 is located in the Ground Floor Disabled WC (see photo 2).</p> <p>The following remedial work should be undertaken to WH 1 and WH 2:</p> <ul style="list-style-type: none"> • The water heaters should be regularly cleaned and maintained on an annual basis according to the ACoP (L8) and manufacturer's instructions and records kept. • The hot water flow temperature from WH 1 was recorded at 58.9°C, this should be raised to at least 60°C. The outlet temperature from the water heater must be kept at 60°C or above leaving the water heater and at least 50°C prior to the outlets or thermostatic mixing valve(s) as fitted. • Investigations should be made to assess and rectify the reason why the hot water temperature did not attain the recommended 50°C to the TMV located in the Ground Floor Ladies WC. • WH 1 flow and temperatures should be monitored and recorded on a monthly basis. • It is understood that WH 1 is approaching end of life. It is recommended that consideration should be given to replace WH 1 with a combination type water heater. • WH 1 should be checked on a monthly basis to confirm the heater is producing hot water (>50°C) at sentinel outlets. In a non-circulating (single pipe), the sentinel points would typically be the taps furthest (far sentinel) and the nearest (near sentinel) to the hot water heater (calorifier) (see 4.4 Hot and Cold Water Service Outlets). • WH 2 should be checked regularly on a monthly basis to confirm the heater operates at between 50°C - 60°C, or check the installation has a high turnover. Water heater flow temperatures to the sentinel or farthest outlet (Ground Floor Committee Room & Bar Sink)) should be monitored and recorded on a monthly basis (see 4.4 Hot and Cold Water Service Outlets). • All monitoring procedures and remedial actions taken must be recorded within the sites log book. <p><i>For further guidance see:</i></p> <ul style="list-style-type: none"> • <i>Legionnaires' disease: The control of legionella bacteria in hot and cold water systems. HSG274 Part 2 Published 2014.</i> • <i>BS 8580:2010 BRITISH STANDARD Water quality – Risk assessments for Legionella control– Code of practice.</i> |

Photo 1 – WH 1 Located in the Lower Ground Floor Boiler Room

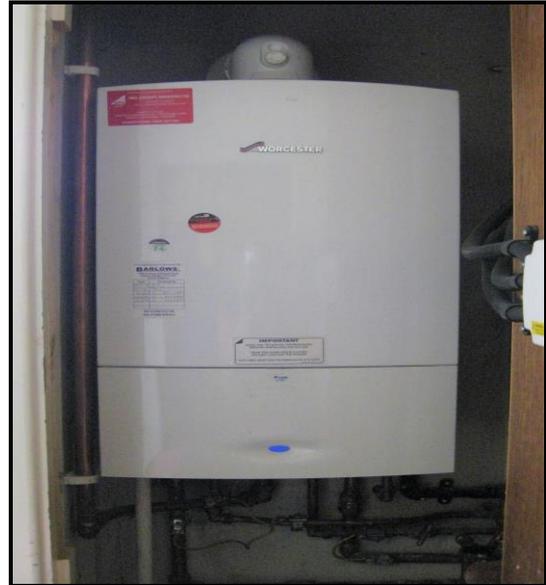
Photo 2 – WH 2 Located in the Ground Floor Disabled WC

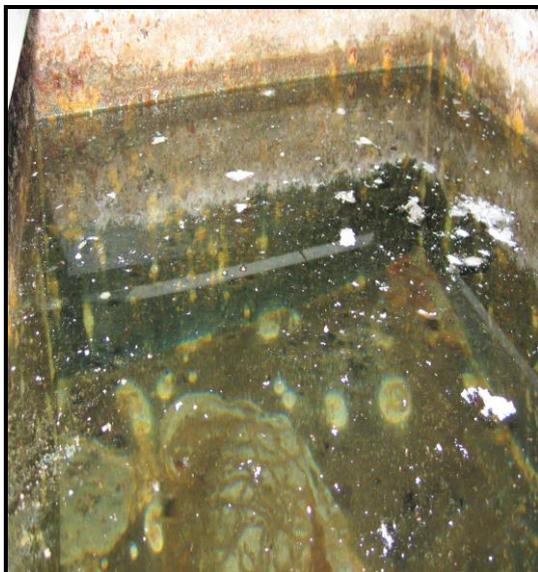
| RAR / Survey Results Reference | Comments and Action Required |
|---|---|
| <p>Medium</p> | <p>There are two Cold Water Storage Cisterns (CWST) located on site used for domestic purposes. CWST 1 and CWST 2 are located in the Roof Space above the Ground Floor Gents WC.</p> <p>It is recommended that the following remedial work is undertaken to CWST 1 and CWST 2 (see photo 3):</p> <ul style="list-style-type: none"> • It is recommended that the CWST's are visually inspected on an annual basis and if deemed necessary, drained down, cleaned and or disinfected. All monitoring procedures and remedial actions taken must be recorded within the sites log book. • There is medium sediment present within both cisterns. The cisterns should be visually inspected within the next six months, and if deemed necessary, drained down, cleaned and or disinfected. • The pipe work insulation is incomplete and should be insulated to comply with BS 5970 2012 and BS EN 806 (2) 2005. • The cisterns are configured and linked in a manor that does not comply with The Water Supply (Water Fittings) Regulations 1999. <ul style="list-style-type: none"> ➢ Water inlet and outlet are not opposed ➢ Neither cistern has a tight fitting lid ➢ Neither cistern is appropriately insulated ➢ Each cistern should have a separate flow which may be used in order to link the cisterns • The cisterns require relining/replacement. • It is recommended to consider the requirement for the cisterns and their maintenance and consider draining/removal and connection of associated WC outlets to the mains cold water supply. <p><i>For further guidance see:</i></p> <ul style="list-style-type: none"> • <i>Legionnaires' disease: The control of legionella bacteria in hot and cold water systems. HSG274 Part 2 Published 2014.</i> • <i>HTM 04-01 Part A - Water systems Health Technical Memorandum 04-01: The control of Legionella, hygiene, "safe" hot water, cold water and drinking water systems Part A: Design, installation and testing.</i> |

Photo 3 – CWST 2 Located in the Roof Space Above the Ground Floor Gents WC

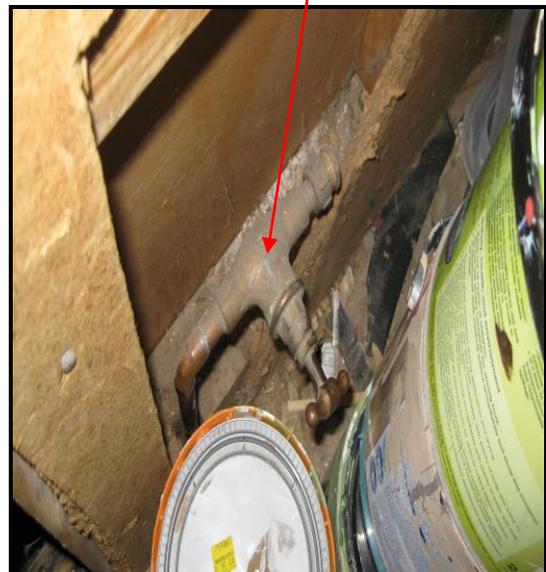
| RAR / Survey Results Reference | Comments and Action Required |
|---|---|
| Medium | <p>There is a redundant or dead end pipe work located above the Ground Floor Main Hall Stage (see photo 4). Dead end pipe work (DEP) and or units should Always be removed when identified.</p> |

Photo 4 – Dead End Pipe Work Located Above the Ground Floor Main Hall Stage
